Architectural paint research in Lower Silesia

Research on the historical colours of Silesian architecture has been undertaken in order to identify original colour schemes of exteriors from the Middle Ages to the present day. Archival research was identified as a source of data on original colour schemes, and the following sources were analysed: documents recording examinations of exteriors, written sources, and colourful depictions. As a result, numerous colour schemes were detected. This paper discusses selected issues on architectural paint research that took place in Lower Silesia in the years 1945-2014. In the first part, the paper presents selected findings of historical colour schemes resulting from later repainting, whereas in the second part, it tackles several technical issues about paint research. The study deepens the knowledge of historical colour schemes of Lower Silesia. It may also enable the improvement of historical paint analysis, thereby allowing better preservation of original polychromes and, as a result, monuments restored closer to their original state.

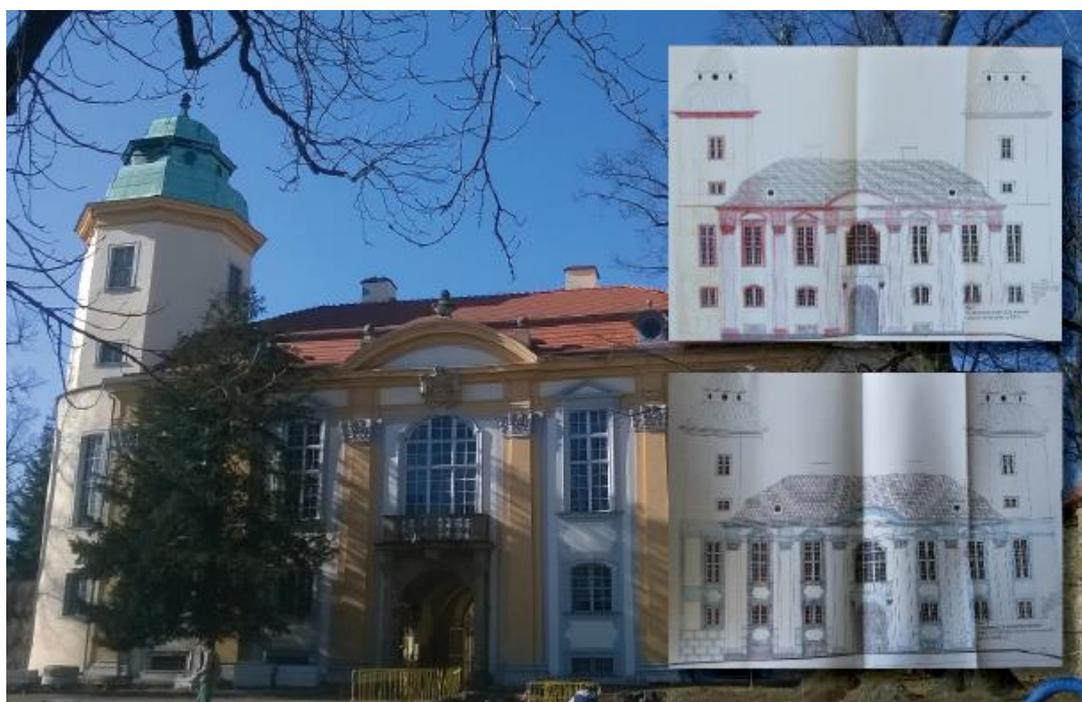
Figure 1: The gate house of the Książ estate in Walbrzych. The building today (photo by the author, 2014). Sketches of the detected Baroque colour schemes: (upper drawing) colour scheme from the first phase, (lower drawing) colour scheme from the second phase. Photo by the author, sketches by Elżbieta Grabarczyk.

Two different colour schemes discovered on a gate building in the Książ estate were linked to the Baroque period. The first colour scheme dated to 1719 was two-coloured: the walls were painted yellow ochre and the architectural details including stone parts were dark red/orange/yellow-ochre brown. The building was repainted in the late 18th century. The white colour was chosen for the walls whereas the architectural details were painted grey/ blue-grey (that hue was achieved by adding charcoal to lime) (see Figure 1).

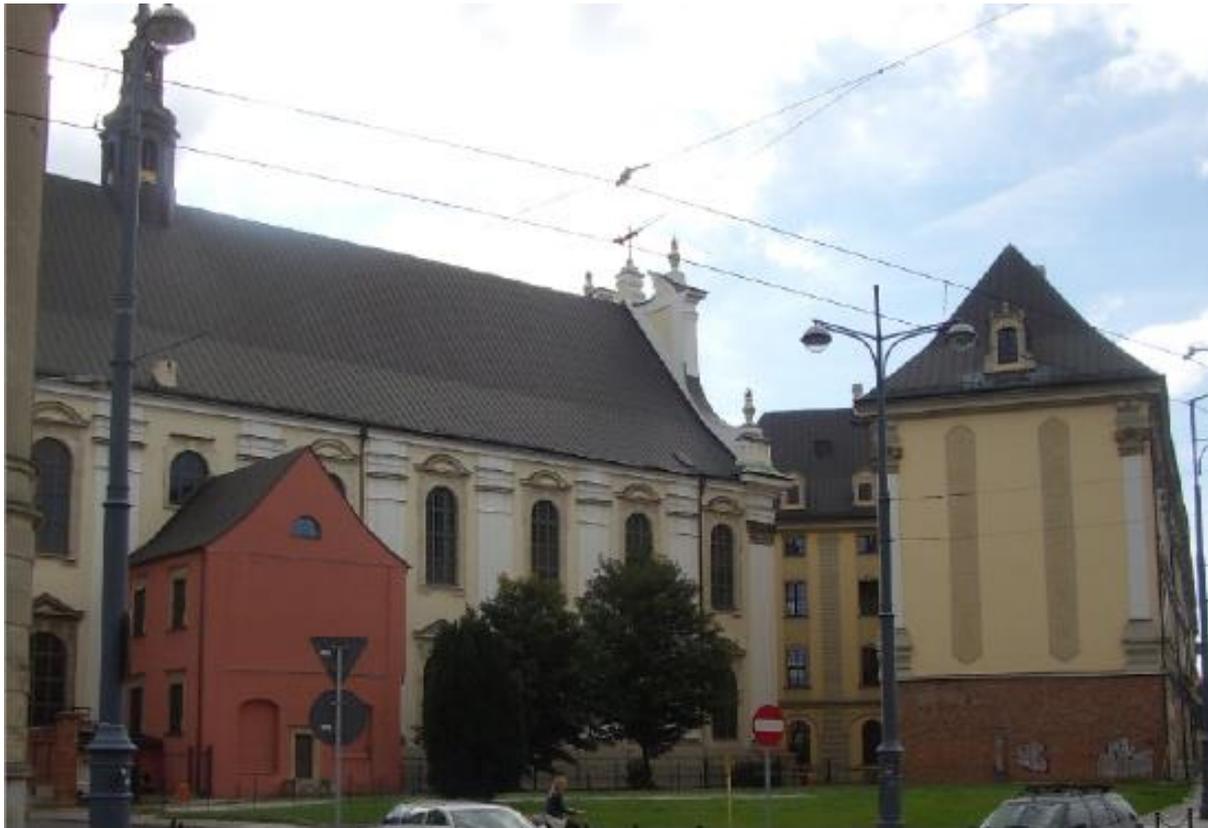
Figure 2: Ulica Grodzka, Wrocław. The Renaissance remains of the royal castle were painted red during the recent refurbishment, a hue linked to the refurbishment at the turn of the 19th and 20th centuries (Photo by the author, 2012).

Red was also detected on cement plaster that covered the Renaissance building, the only remain of the royal castle. A conservator who examined elevations suggested that the use of no-lime binder, probably casein, indicated the very late origins of red paint - the 19th century or the beginning of the 20th century (see Figure 2).

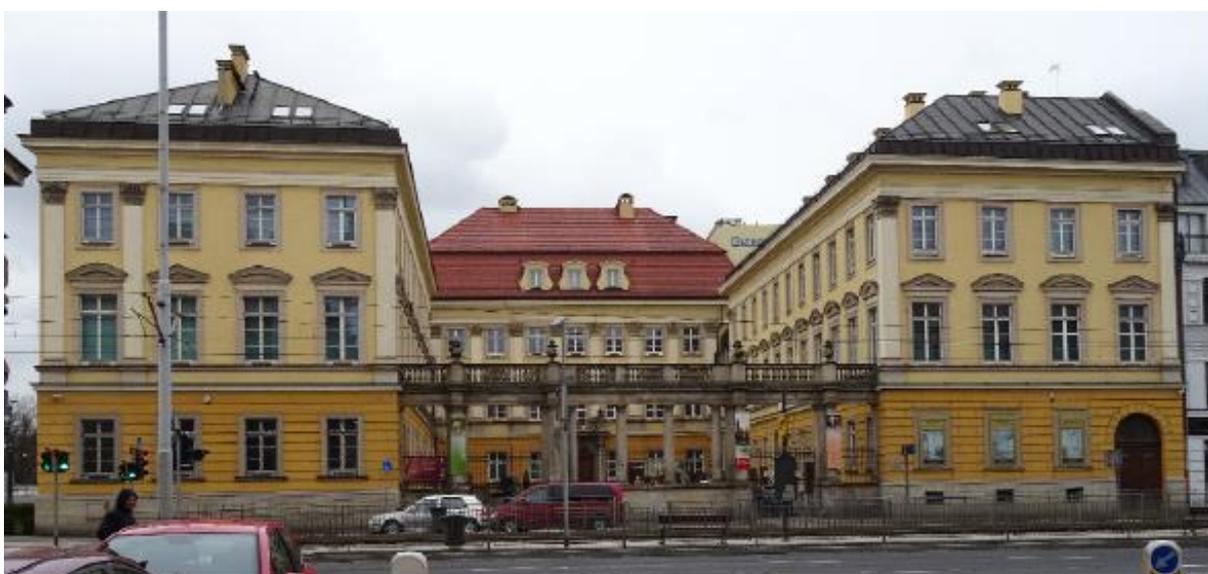
Figure 3: The former palace at 34-35 ulica Kazimierza Wielkiego, Wrocław. In the mid-19th century the wings were added and the whole palace was repainted reddish pink (Photo by the author, 2016).

Reddish pink was detected on a former royal palace at 34-35 ulica Kazimierza Wielkiego, Wrocław. The palace was built around 1719 and expanded a few times in the mid-18th century, late 18th century and mid-18th century. Examinations revealed that all the wings of the palace were covered the same sand-lime, light grey plaster and painted red-pink with a lighter shade applied to the walls and a darker shade to the window surrounds (250/12, 250/22, 260/21, 260/31 in the ISPO EuColor System colour chart). This colour scheme was linked to the 1858 expansion works when the wings were added (see Figure 3).

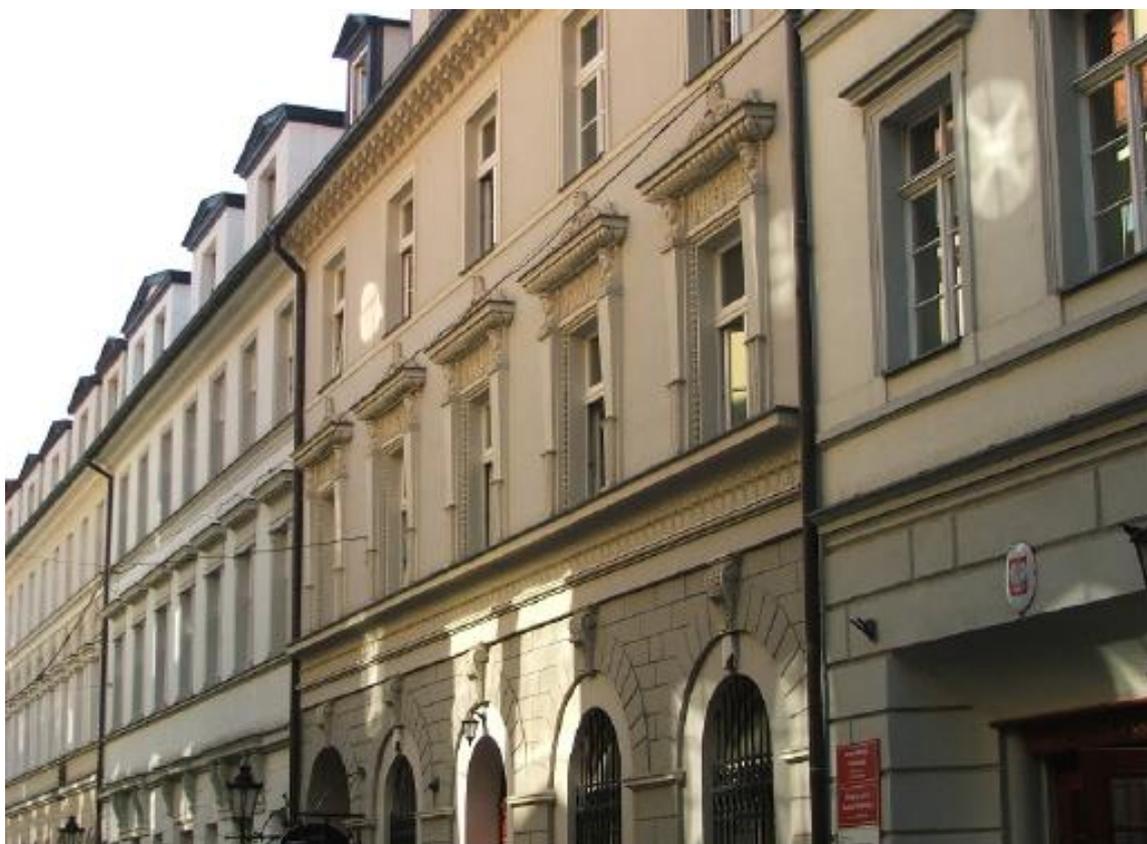
Figure 4: 9-13 Sukiennice, Wrocław. In the second half of the 19th century the row of classical dwellings was repainted in various hues: beige, brown, cream, pink, yellow ochre (Photo by the author, 2012).

Examinations of the Wrocław dwellings at 9, 10, 11, 12, 13 Sukiennice, erected in the years 1821-24, revealed the colour schemes used in the second half of the 19th century. At that time, the buildings were painted the following way: yellow (dwelling number 9), beige (number 10), yellow ochre and pink on the walls and cream, pink and white on details (number 11), brown on the walls and yellow ochre / pink on the architectural details (number 12), sandy/ brown (number 13). The dwellings at number 11 and 12 had lighter architectural details, otherwise the buildings were painted uniformly (see Figure 4).

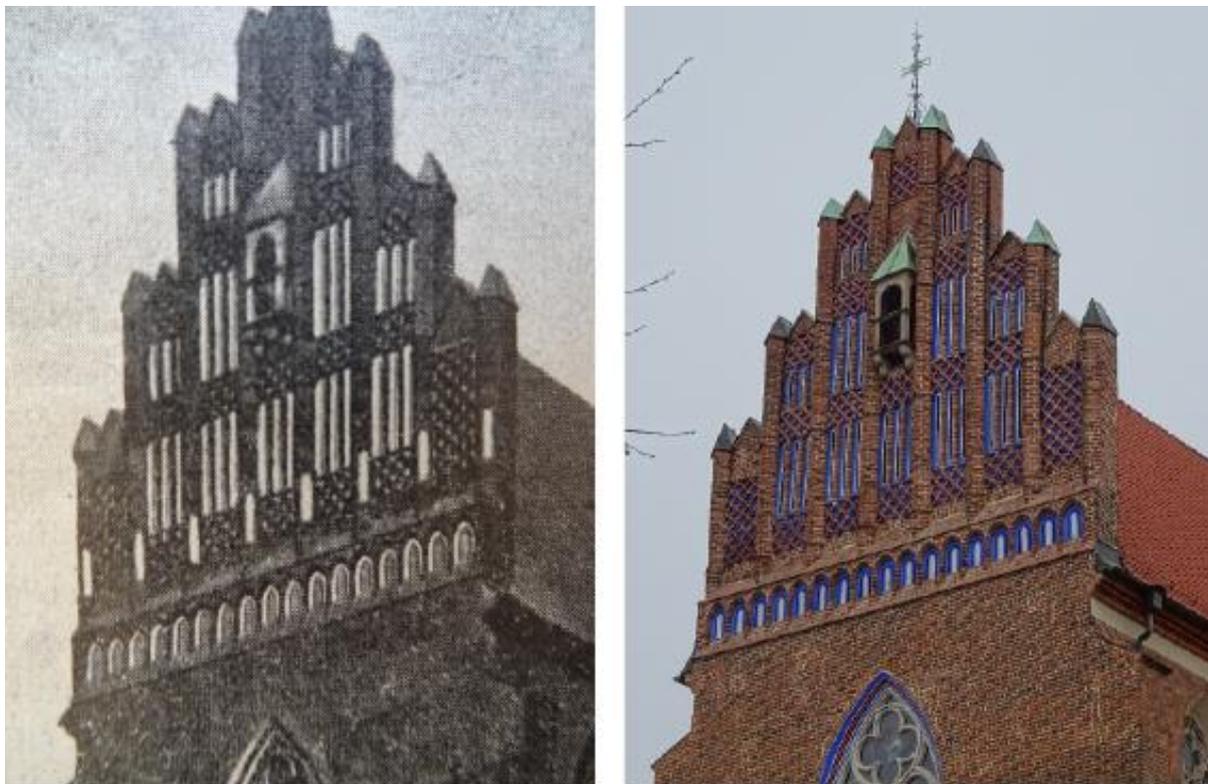
Figure 5: The Corpus Christi church, Wrocław. The medieval gable was painted in the 1920s (left). By Schlesischer Malerbund, 1928, vol. 11, 367-369. The detected colour scheme was restored a few years ago (right). Photo by the author, 2014.

The neo-Gothic polychrome from the beginning of the 20th century was discovered on a façade of the medieval Corpus Christi church at 26 ulica Świdnicka, Wrocław. The following intense hues were discovered: black, blue, red and white (see Figure 5).

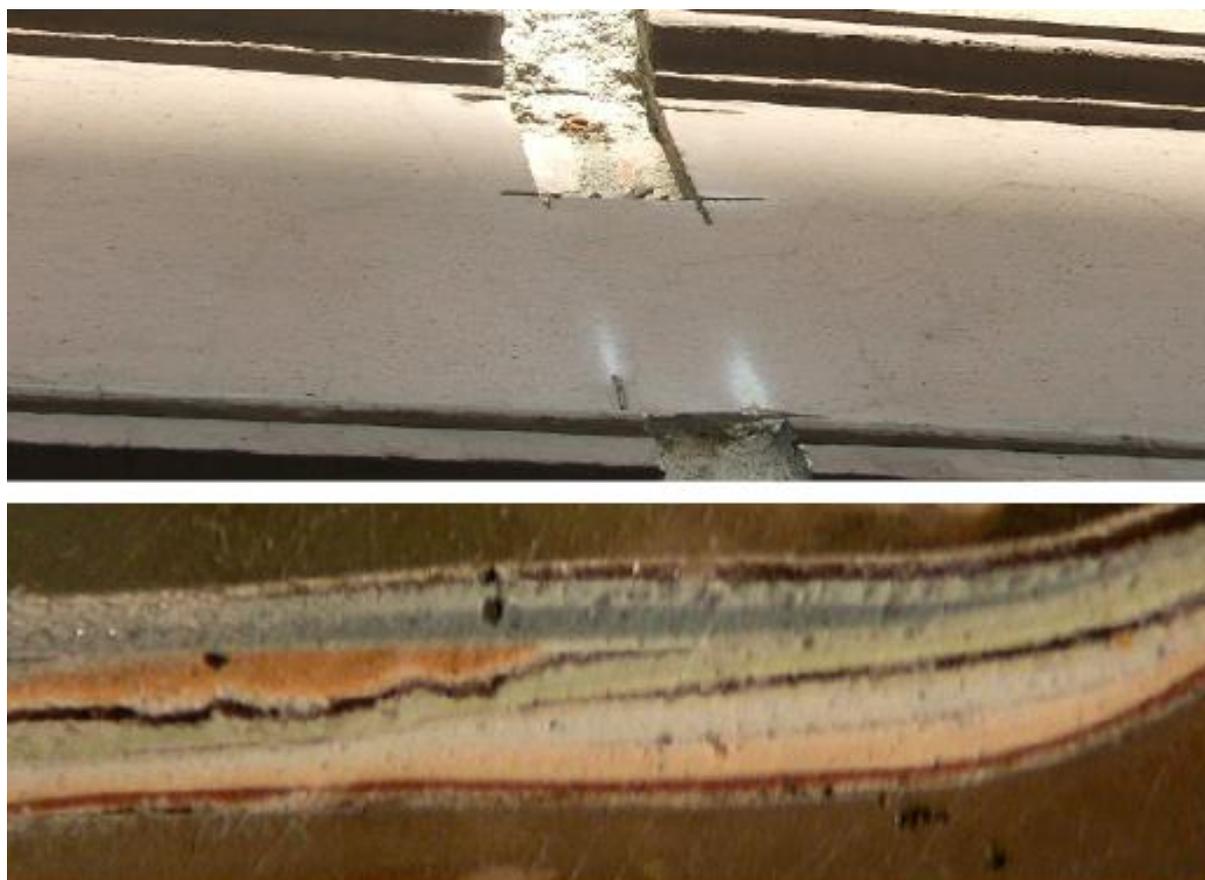
Figure 6: The difference in visibility of the sequence of plaster and paint layers on site and under the microscope. By the author (upper picture), courtesy by Barbara Kubisa (bottom picture).

In regard to the methodology of paint research the following steps were differentiated by studying Silesian records: building history analysis that includes depictions and written sources; on-site analysis meaning observation by human eye without portable devices; microscope analysis of cross sections; chemical analysis in a laboratory of mortar and paint components; non-invasive methods (see Figure 6).

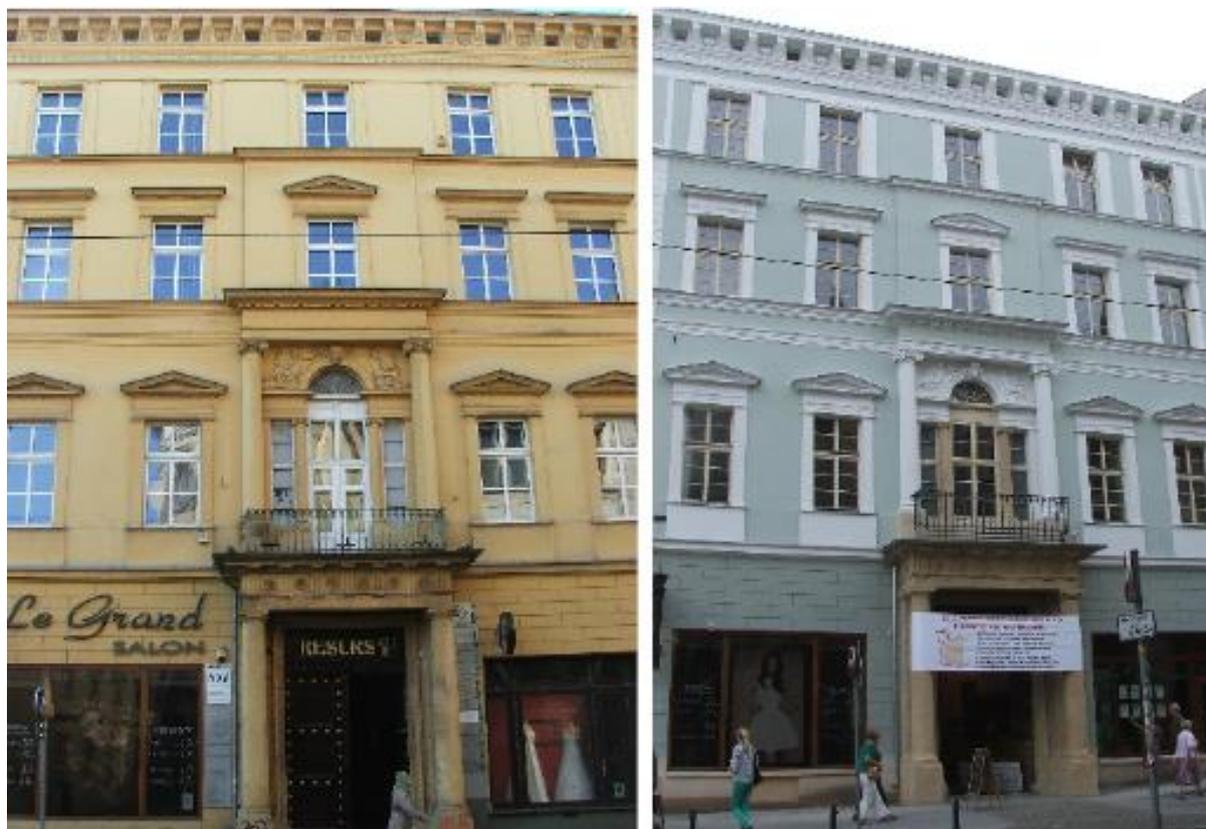
Figure 7: 16 ulica Wita Stwosza, Wrocław. Yellow ochre was estimated as the original colour by on-site observations (left). Re-examinations with the analysis of selected samples under the microscope revealed that the building was originally painted monochromatically grey-green. The grey-green layer of paint was visible beneath yellow ochre under the microscope (Photos by the author in 2012, 2015).

Re-examinations of a Wrocław dwelling at 16 ulica Wita Stwosza allowed to clarify results of first examinations that took place in 1998 and were limited to in-situ observations. At that time it was established that originally the building was painted intense yellow ochre. Conducted in 2013, second examinations included the analysis of selected samples under the microscope. During observation under the microscope it was clearly visible that yellow ochre was in fact a second chronological phase and the building was originally painted grey-green (see Figure 7).

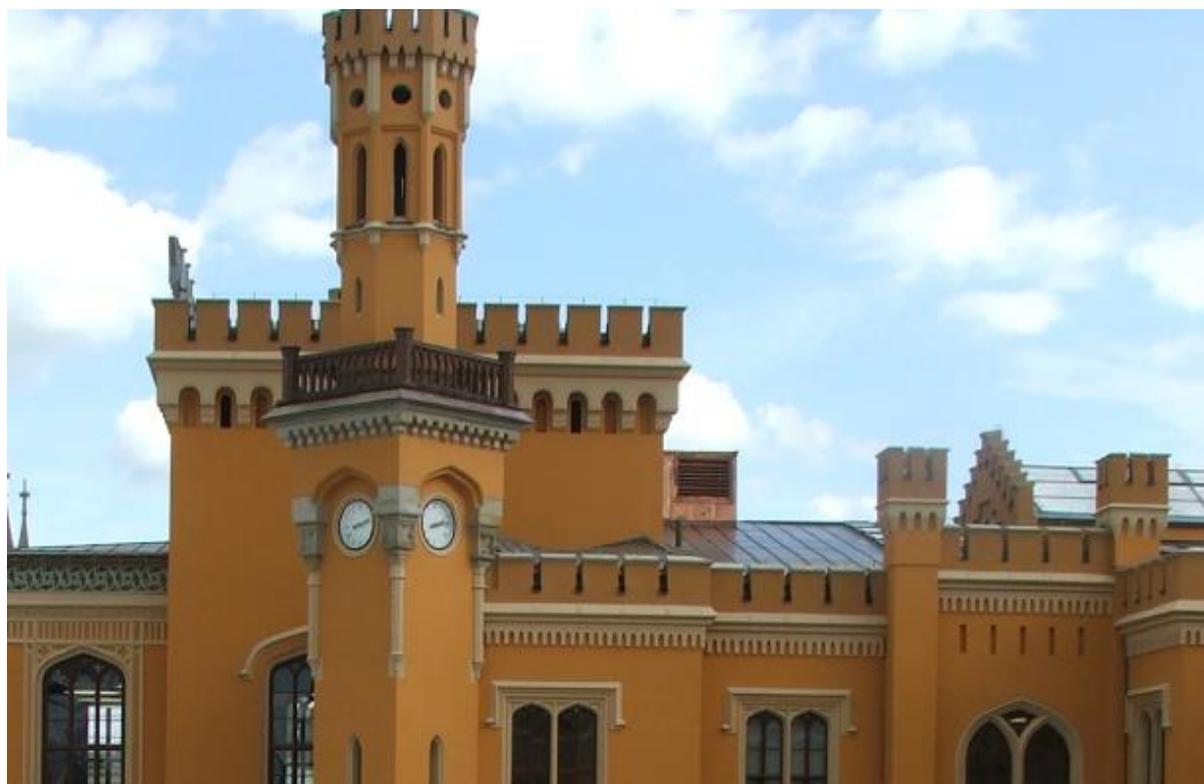
Figure 8: The railway station Wrocław Główny - detail. The elevations were partially restored to the original colour scheme from the mid-19th century. The colour scheme was possible to detect due to the full access to the building.

Examinations of the main railway station building were conducted by two different conservators, the first one prior the refurbishment and the other one - during the refurbishment. The first conservator had limited access to the building and the other conservator conducted examinations with full access during the refurbishment. As a result, the first conservator assumed that the building was probably originally painted light beige/ sandy hue. However, due to the better access to the building the other conservator established that the light yellow ochre was in fact the second chronological phase, and that the building was originally painted monochromatically intense yellow ochre-orange, with the exception of the stone parts exposed without painting. The window frames were painted dark brown (see Figure 8).

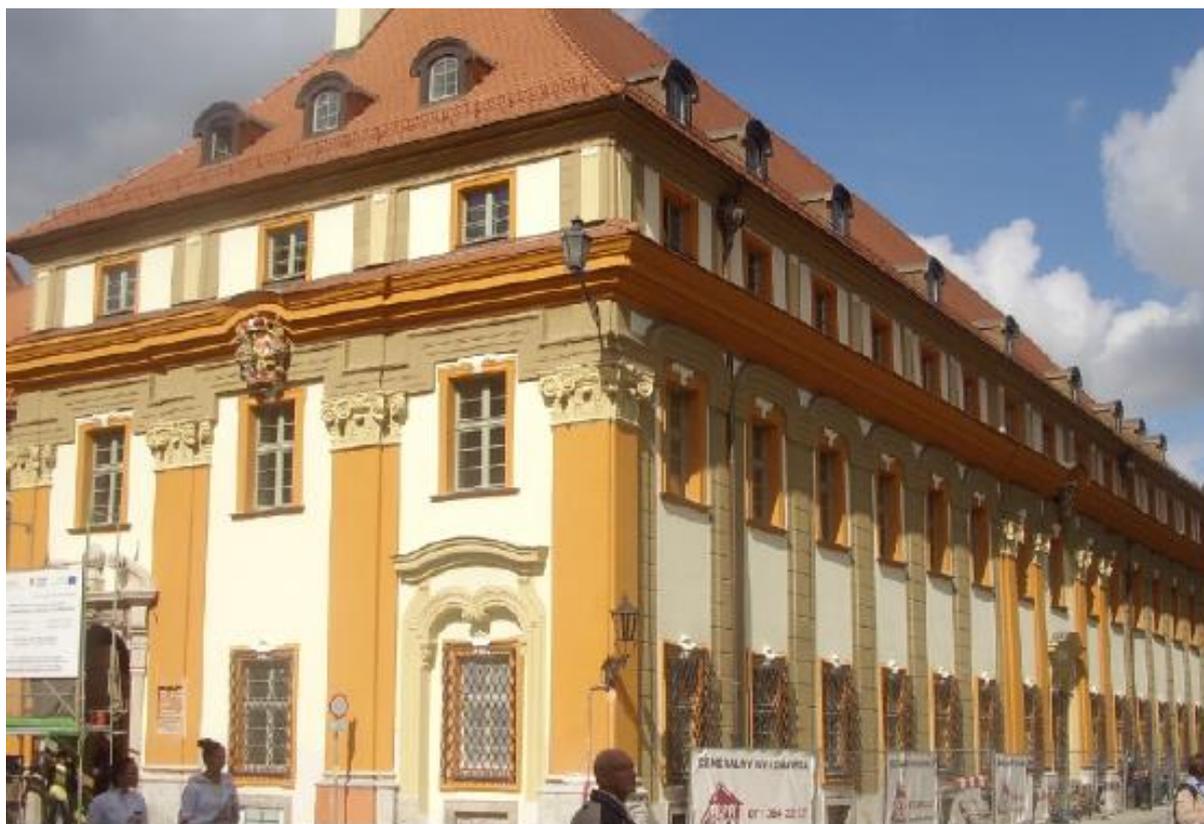
Figure 9: The former orphanage at 4 ulica Katedralna, Wrocław was restored to one of two colour schemes suggested by a conservator who made an on-site examination (Photo by the author, 2012).

It was also confusing when a conservator who conducted paint research provided a few possible colour schemes described as from the first chronological phase. For example, the former orphanage located at 4 ulica Katedralna in Wrocław was examined in situ. A conservator who examined the Baroque building supposed that the north elevation was originally two-coloured: light yellow was applied to the walls and yellow ochre – orange to the architectural details. The conservator also presumed that the east elevation was originally three-coloured: yellow, orange and brown. According to the conservator, both versions could have been original colour schemes as they were similar; however, it was not clearly stated if the elevations were painted differently at the same time, or if both versions were possible, but only one of them was applied to the elevations (see Figure 9).

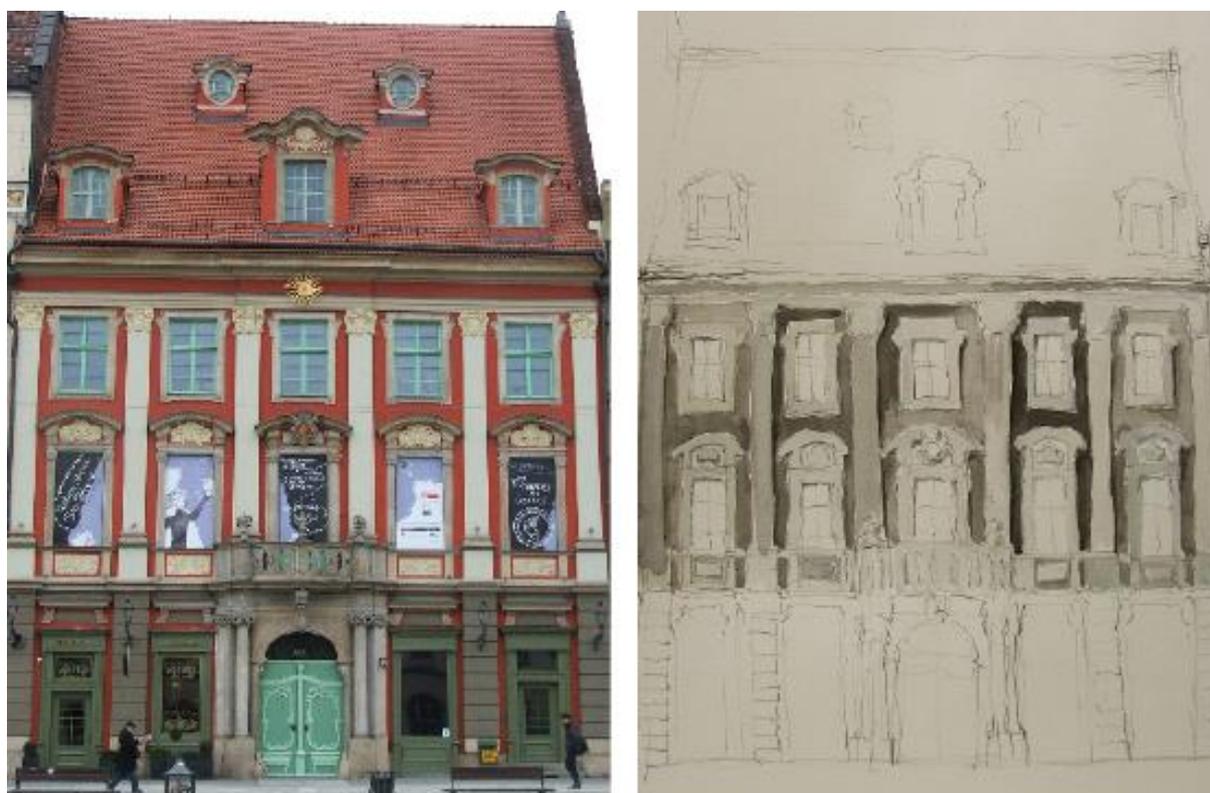
Figure 10: 6 Rynek, Wrocław. The building has been rebuilt and redecorated a few times since the Middle Ages. The second examinations revealed traces of colour schemes: red-pink paint (1st phase) and light yellow ochre (2nd phase), both possibly from the period before the Baroque refurbishment. The dark grey and grey colour scheme was discovered directly on the Baroque window surrounds (Photo and sketch by the author, 2013).

Yet, some provided explanations occurred to be very detailed and valuable; nonetheless, conclusions were somehow unclear and brought more confusion. For example, two different examinations were conducted on a medieval dwelling at 6 Rynek in Wrocław, rebuilt in the Baroque style in 1727. The first examinations of the façade took place in 1988 and the other in 2006. The latter, which were by far more detailed, revealed up to six chronological phases. The third chronological phase was described as dark grey or grey (the walls were either black or dark grey, pilasters were dark grey and moulding – grey or yellow ochre). Those colours were detected directly on the same plaster that covered the walls and the Baroque window surrounds. This description seems to indicate the Baroque origins of that phase¹³, yet it was linked to the 19th-century refurbishment in the conclusion part (see Figure 10).

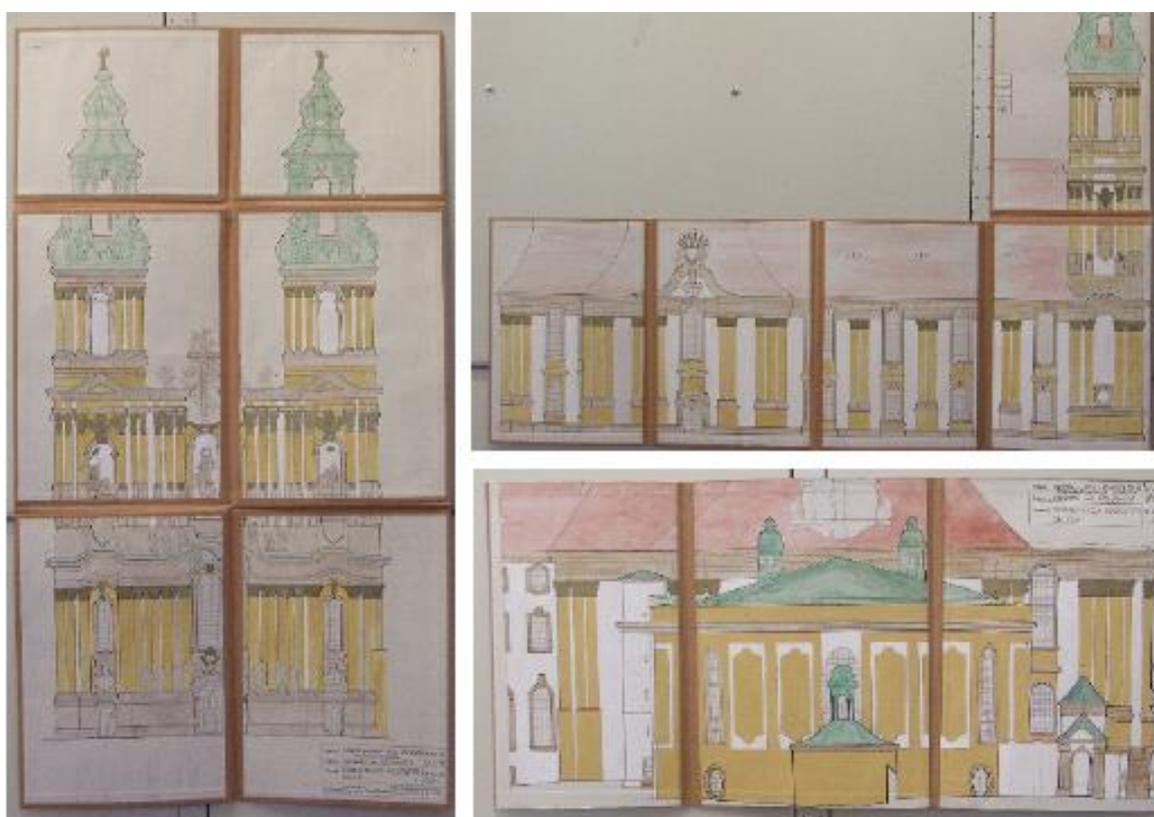
Figure 11: An example of a depiction of a discovered colour scheme that helps to understand achieved results and avoid wrong or unclear conclusions. Reconstruction drawing of the original colour scheme of the former Cistercian church and the mausoleum in Krzeszów. Drawings by Anna Dorak.

Generally speaking, documents aim to record the work for future references. The examined records varied from a single sheet of paper to a heavy report with tiny samples added to the documentation. A letter in a form of a single sheet of paper usually informed that examinations were conducted and provided information on colours of the first chronological phase without any explanation in what way the examinations were conducted. Most of the examined documents consisted of several pages and provided information on the goal of paint research, scope of the work, and colours that were detected. Some of reports provide a brief history of a building and discussed methodology of examinations including pictures taken on site, under the microscope and in the chemical laboratory. Some of the analysed reports included depictions of reconstructed colour schemes that additionally explained the intentions of the author of a record and helped to avoid confusion in case some information was missing in the text (see Figure 11).

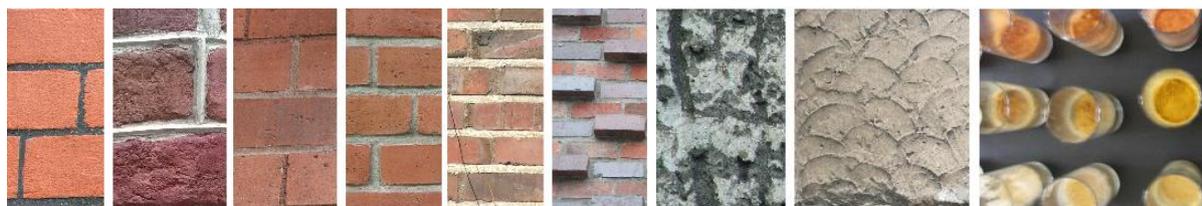
Figure 12: A description: painted colour of brick, or plaster or ochre may mean in fact one of a few colours. A few colours and shades of brick, plaster and mineral pigment ochre. Photos by the author, 2011-2013.

Furthermore, descriptions of colours such as: ‘painted colour of stone’, ‘painted colour of brick’, ‘colour of iron red’, etc. are misleading (they presumably mean something to the author of the report but not necessary to the audience). For example, the expression ‘colour of stone’ is too vague - even if one would like to narrow colours of stone to those mined in Silesian quarries they vary from white, yellow, pink, red to grey and brown. Similarly, colours of medieval bricks vary in Silesia from cherry red to orange; and the issue becomes even more complicated as in the 19th century the colour range gets enriched by yellow, white, black, green, etc. and also purple in the early 20th century. Even a comparison to a pigment is risky as, for example, green earth is described in textbooks as either ‘green-grey’ or ‘grey-green’; an iron red pigment is described in textbooks in the following way: ‘iron reds differ in hues depending on the precise method of preparation and composition: light yellow, dark yellow, red, brown and chestnut’; etc. (see Figure 12).
